Loveland Water and Power

**Big Thompson River Watershed  
Source Water Quality Conditions**

**Fall 2022**

January 23, 2023

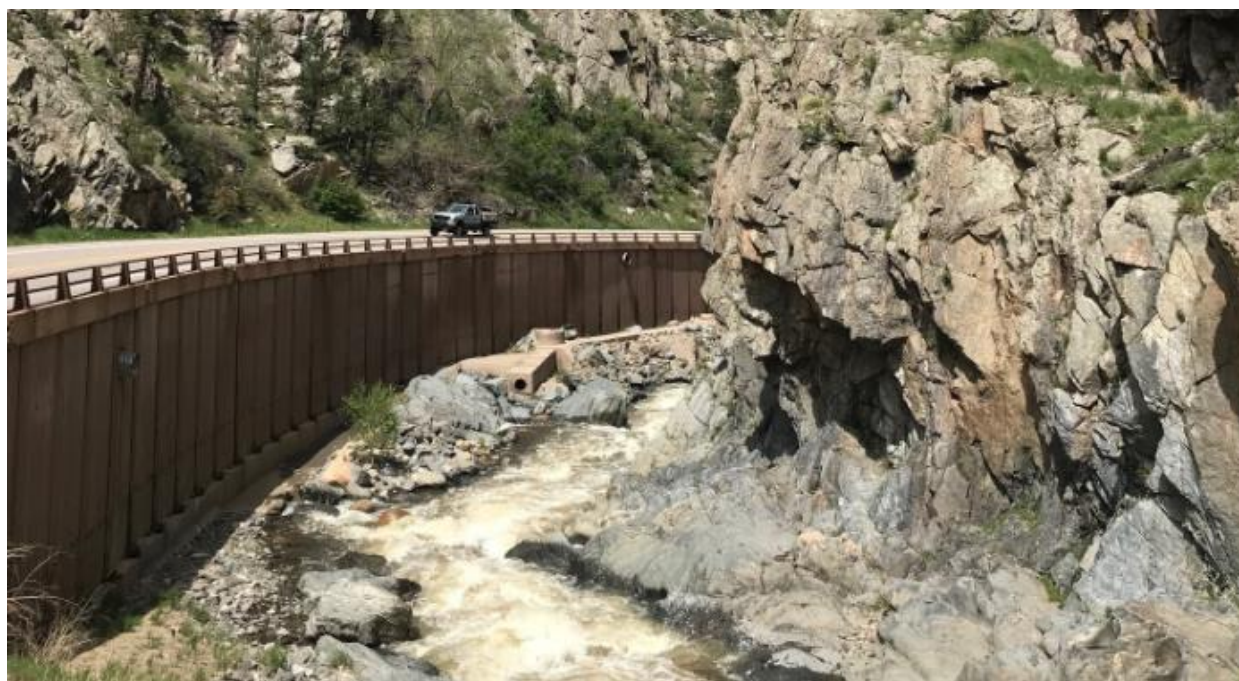
**Figure 5. Average pH values for the months of August through October 2017-2021 (blue bar) and the 2022 average value (red dot) at sites included in the LWP SWMP.**

Mean pH values were generally near five-year average values for virtually all sites in fall 2022 (Figure 5). However, pH was somewhat elevated in Pinewood Reservoir and was somewhat depressed in the remaining CB-T locations. White ash is the lightest in weight the finest in terms of coarseness and therefore it is generally flushed from the system at a faster rate than black ash, it also generally has a higher pH than black ash (Rodela et al. 2022). Black ash can still be seen in the river during high water events. Relatively low pH values documented in the Colorado-Big Thompson Project (CB-T) sites are potentially due to black ash that remains in the system as a result of the East Troublesome Fire. The cause of the somewhat elevated pH in Pinewood Reservoir is unknown. Although the variations from the average values in the CB-T sites seem relatively small (~0.3 SU) it is important to note that pH is measured on a log scale. Therefore, a difference of ~0.3. SU is approximately equivalent of a doubling of the concentration of hydrogen ions. None of the measured pH values exceeded standards set to protect aquatic life in fall 2022.

The pH value (SU, Standard Units) measures how acidic or basic the water is. A pH value of 7 is considered neutral, with lower values considered acidic and higher values considered basic. Colorado Regulations 31 and 38 establish a pH of 6.5 as a minimum and 9 as a maximum to protect aquatic life. Generally, pH values increase as water moves from the headwaters to lower in the watershed because additional dissolved materials become present in the water.

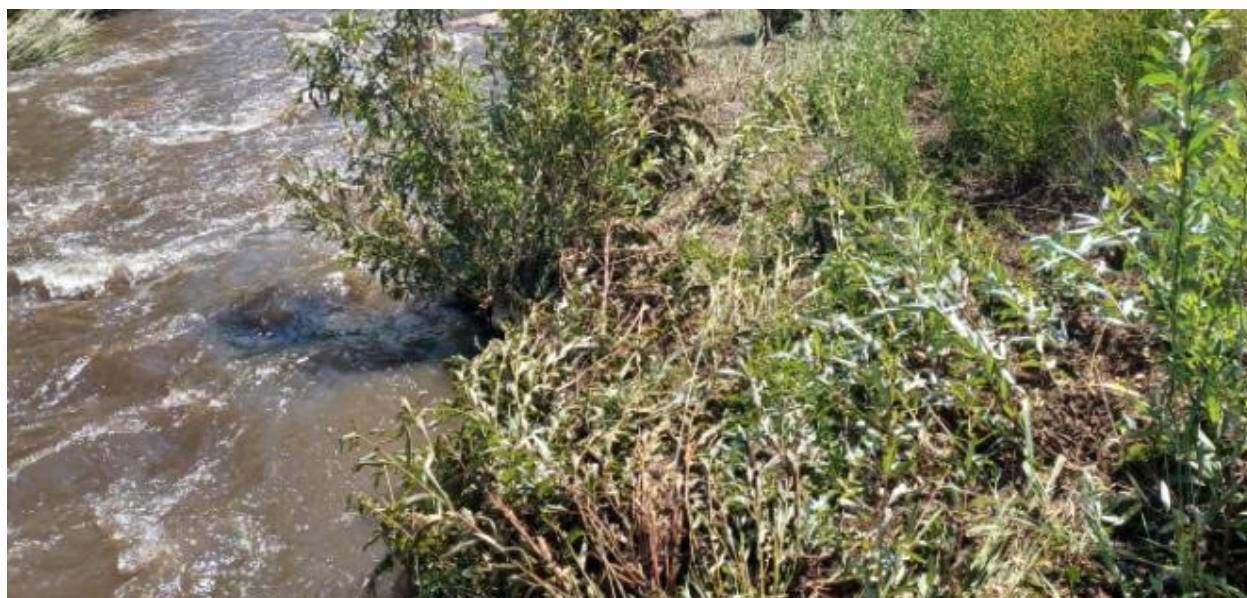
**Figure 12. Average total organic carbon values for the months of August through October 2017-2021 (blue bar) and the 2022 average value (red dot) at sites included in the LWP SWMP.**

Fall 2022 TOC values were somewhat elevated compared to five-year average values at all sampling locations (Figure 12). TOC values have been increasing in Green Ridge Glade Reservoir over the past several years, but this trend was not apparent in fall 2022. The cause of the somewhat elevated TOC values is unknown. It is important to note that despite these elevated TOC values in source water, TOC values remained low in finished drinking water thanks to treatment processes.

Although TOC is not a direct human health hazard, the dissolved portion of the TOC can react with chemicals (chlorine and others) used for drinking water disinfection to form disinfection by-products that are regulated as potential carcinogens (e.g. chloroform  $\text{CHCl}_3$ ). As such, TOC levels are of concern to drinking water treatment facilities.
