Loveland Water and Power

**Big Thompson River Watershed
Source Water Quality Conditions**

Summer 2022

January 23, 2023

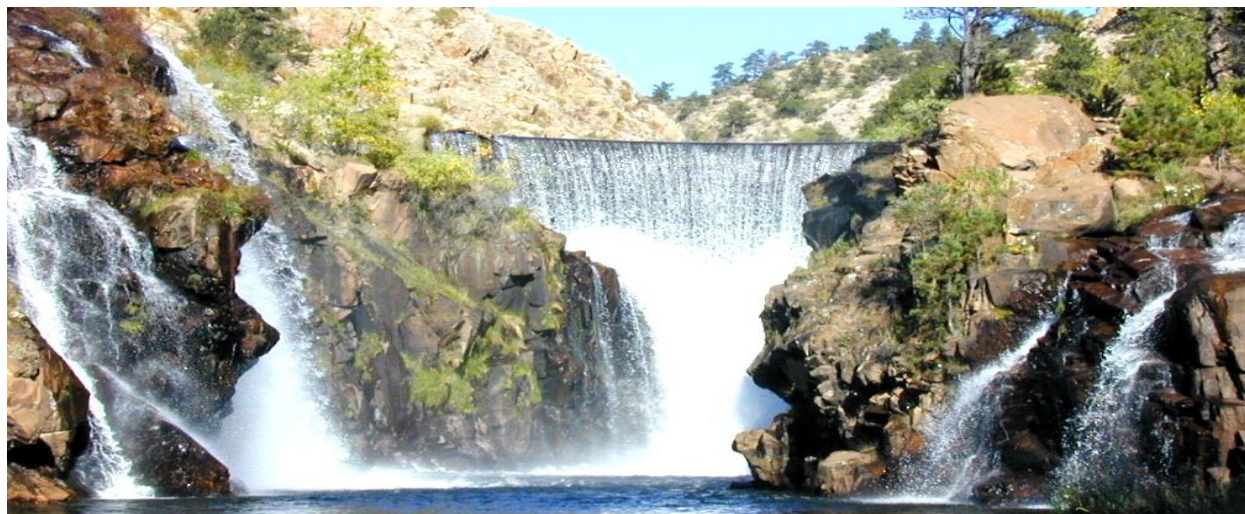
Figure 6. Average dissolved oxygen values for the months of May through July 2017-2021 (blue bar) and the 2022 average value (red dot) at sites included in the LWP SWMP.

Summer 2022 dissolved oxygen levels were slightly below historic averages across sites (Figure 6). However, all values were substantially above standards associated with aquatic life in lotic sites which is a positive indication for aquatic ecosystems in the Big Thompson River Watershed.

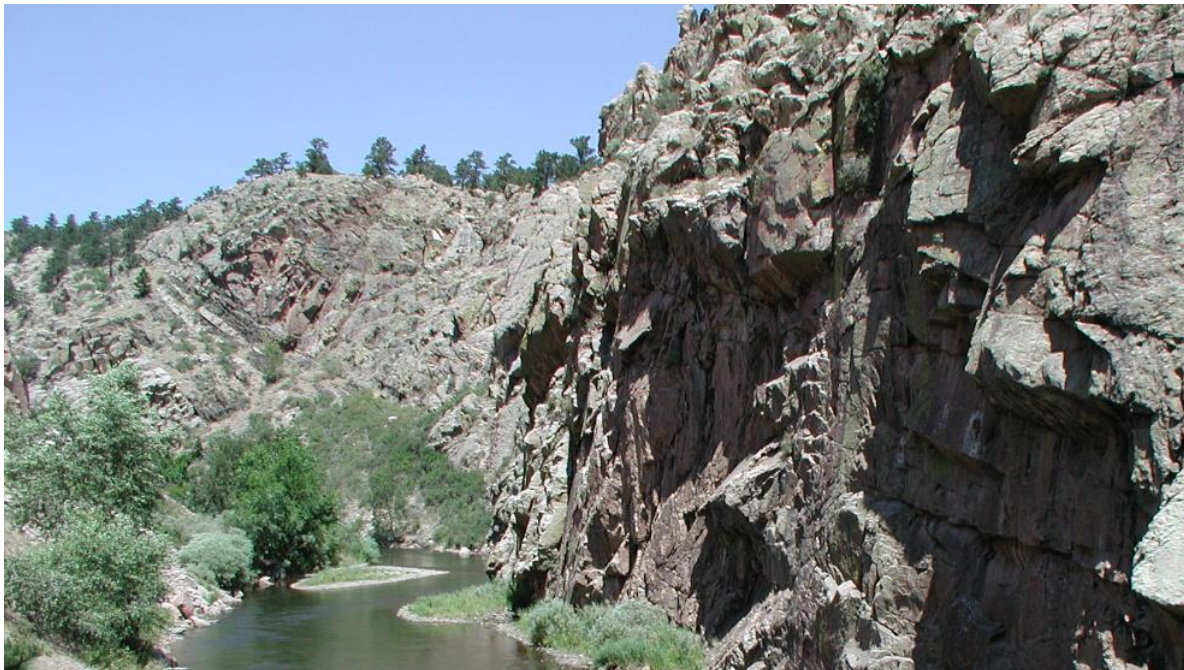
Figure 8. Average total copper values for the months of May through July 2017-2021 (blue bar) and the 2022 average value (red dot) at sites included in the LWP SWMP.

Total copper levels were generally near or substantially below five-year average values in summer 2022 (Figure 8), a pattern that continued from spring 2022. In part, this circumstance could be due to somewhat lower tree mortality caused by bark beetles in recent years (USDA 2019) which would result in decreased dissolved copper in the Big Thompson River. Tree mortality caused by bark beetles may result in copper, which is naturally taken up and stored by trees, being released into surface water upon their death (Fayram et al. 2019). The fact that tree death resulting from the CPF did not result in an increase in dissolved copper in summer 2022 could be due to the fact that the lack of bark beetle mortality more than offset tree deaths caused by the fire or that the predicted increases in copper will only appear after the predicted lag of three years post mortality event (Fayram et al. 2019). Regardless of the cause, lower total copper levels are a positive indication of improving conditions for aquatic communities in the Big Thompson River Watershed.

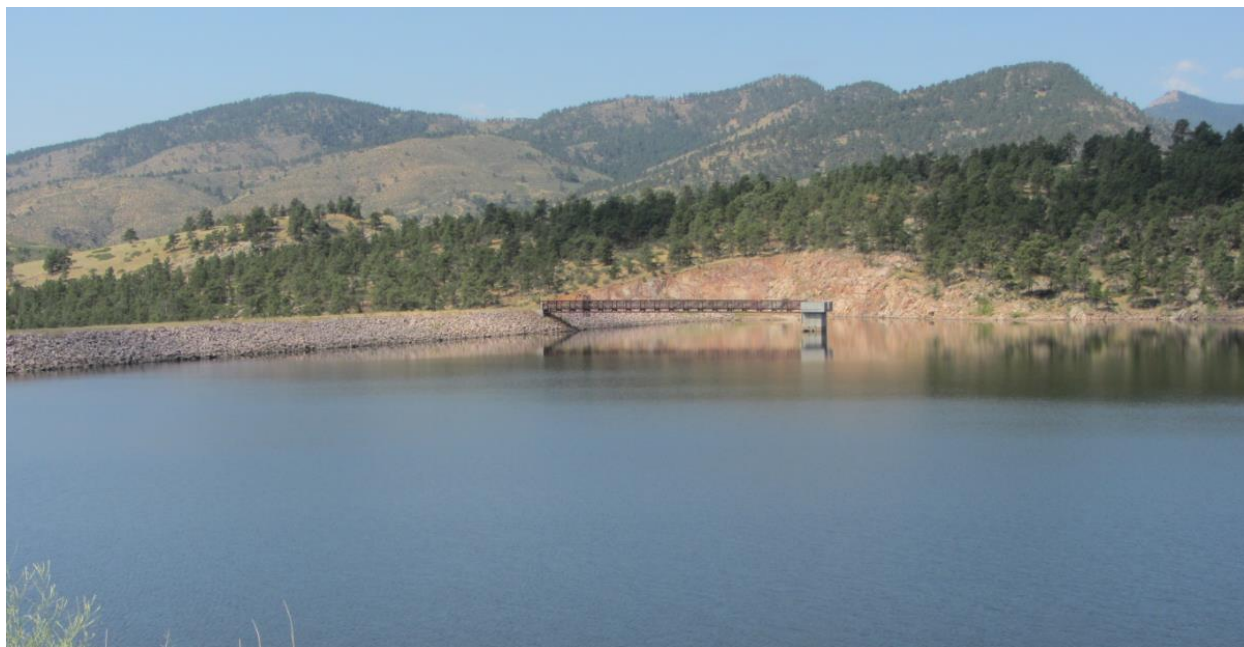
Figure 12. Average total organic carbon values for the months of August through October 2017-2021 (blue bar) and the 2022 average value (red dot) at sites included in the LWP SWMP.

Summer 2022 TOC values were near five-year average values (Figure 12). Notable exceptions are the Fall River and Mary's Lake Bridge sites as well as continued elevated levels in Green Ridge Glade Reservoir where values were somewhat high in 2022. TOC values have been increasing in Green Ridge Glade Reservoir over the past several years. While the exact cause of this increase is unknown, the age of the reservoir and the connection to a wetland on the north side of the reservoir are potential contributors.
