Loveland Water and Power

**Big Thompson River Watershed
Source Water Quality Conditions**

Fall 2023

December 11, 2023

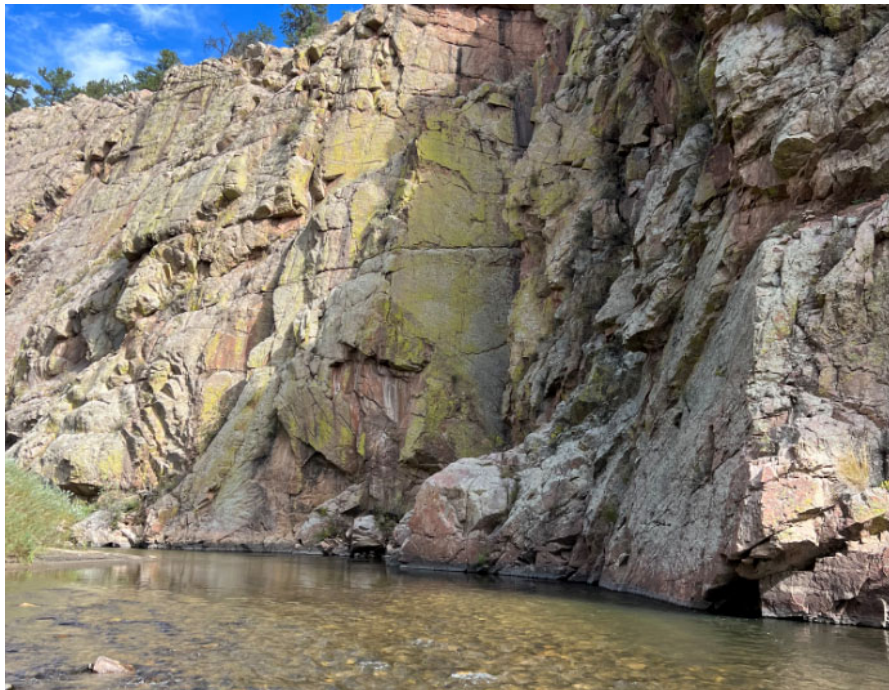
Mean pH values were somewhat lower than five-year average values at most sites in fall 2023 (Figure 5). These lower values are consistent with watershed recovery from wildfire as white ash from wildfires is generally basic (Rodela et al. 2022). Since all the sites continue to receive lower and lower amounts of ash from the CPF or the East Troublesome Fire as time goes on, it is reasonable to expect pH levels to continue to decline in coming years.

Figure 5. Average pH values for the months of August through October 2018-2022 and the 2023 average value (red dot) at sites included in the LWP SWMP. Blue bars indicate mainstem sites, light blue bars indicate tributary sites, and aqua blue bars represent Colorado-Big Thompson sites.

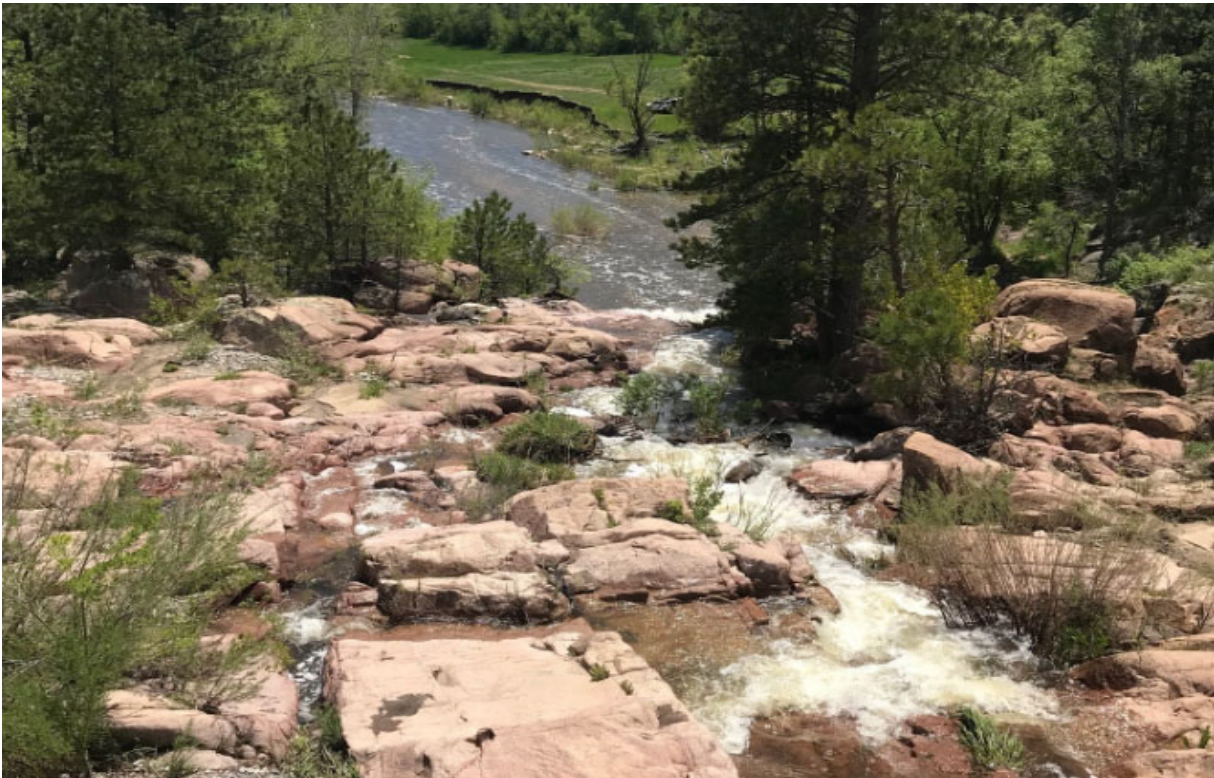
Fall 2023 dissolved oxygen levels were generally very near historic averages across sites (Figure 6). Although dissolved oxygen concentrations were generally near historical values, the fall 2023 dissolved oxygen concentration in the Green Ridge Glade Laboratory Line (S-LNN-20) was notably above the five-year average value.

The high dissolved oxygen levels associated with site S-LNN-20 may be somewhat deceptive. The water sampled is reflective of the depth at which water is being taken from the reservoir to use as drinking water. These depths are associated with different depths of gates in the tower intake control structure. Each gate can be opened or closed to utilize water from different depths of the reservoir. Different depths contain water that has different water quality characteristics. The bottom of the reservoir (hypolimnion) becomes anoxic during the summer months and into the fall. Often, the primary gate utilized for source water is very near the thermocline. Therefore, depending on the depth of the thermocline in a given month, the dissolved oxygen concentration may seem particularly high or particularly low compared to the average concentration.

Figure 6. Average dissolved oxygen values for the months of August through October 2018-2022 and the 2023 average value (red dot) at sites included in the LWP SWMP. Blue bars indicate mainstem sites, light blue bars indicate tributary sites, and aqua blue bars represent Colorado-Big Thompson sites.

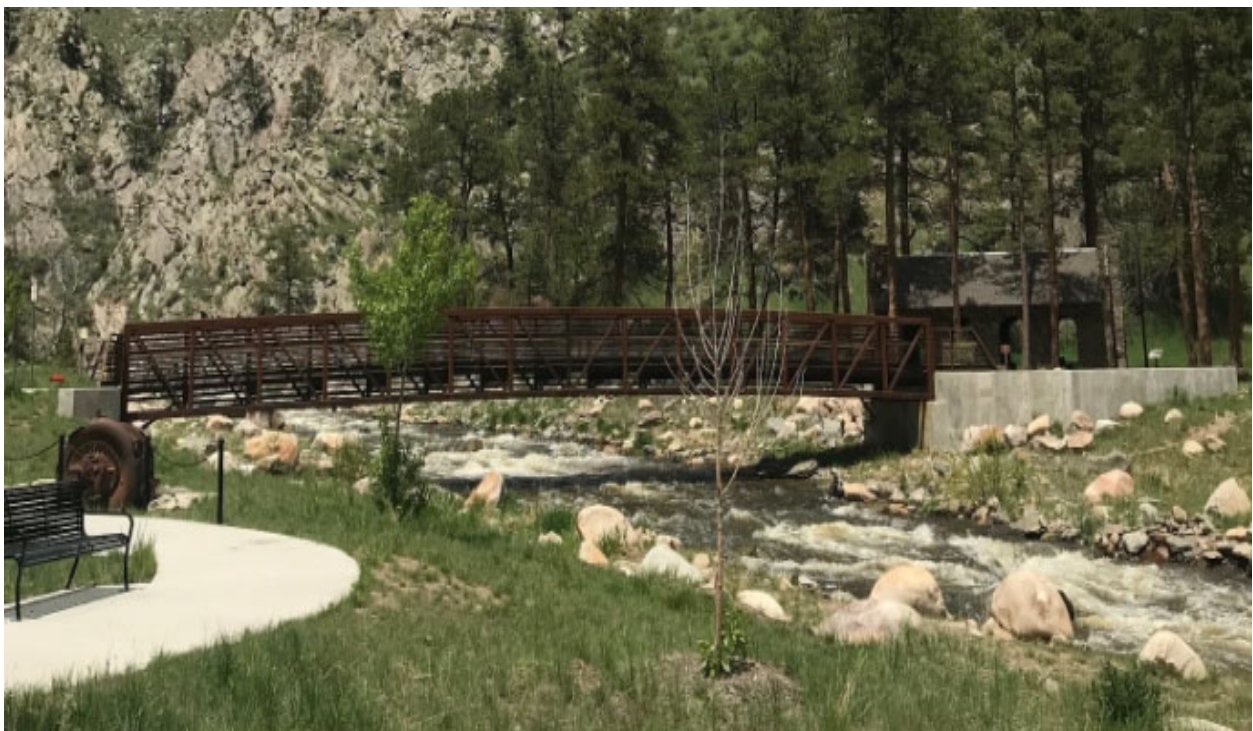
Differences between average values in fall 2023 and average fall values over the previous five years were small.

Figure 7. Average alkalinity values for the months of August through October 2018-2022 and the 2023 average value (red dot) at sites included in the LWP SWMP. Blue bars indicate mainstem sites, light blue bars indicate tributary sites, and aqua blue bars represent Colorado-Big Thompson sites.

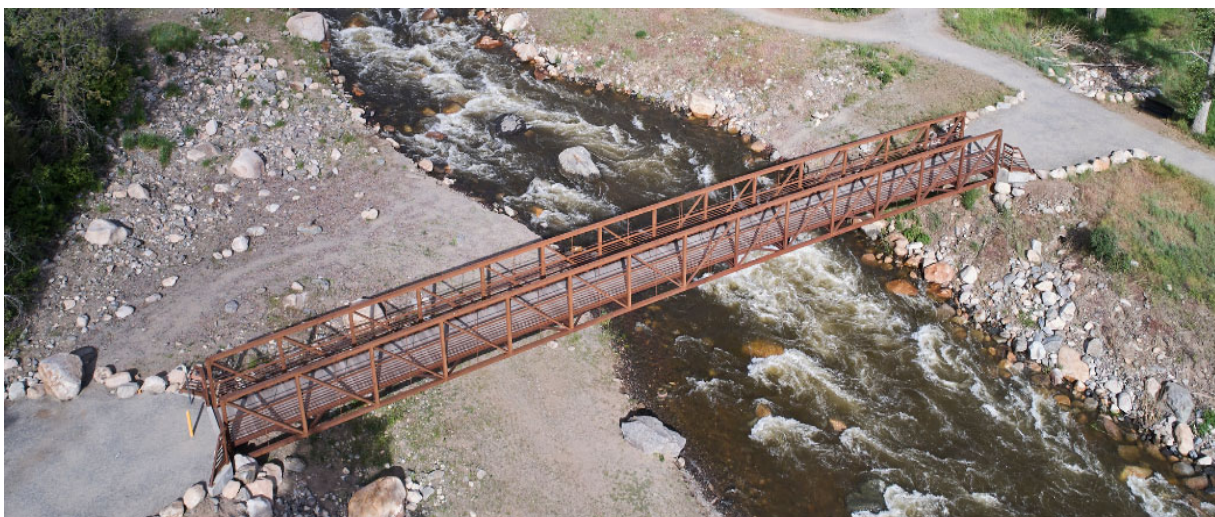
Total copper levels in fall 2023 were below five-year average values (Figure 8) and total copper levels have generally been lower in the post-CPF time period. Although copper levels in the previous year (fall 2022) and season (summer 2023) appeared to be increasing toward pre-CPF copper concentrations, fall 2023 concentrations have declined from previous levels. While these lower levels indicate continued effects of the CPF, they are also positive from a water quality perspective and represent one of the few positive outcomes of the CPF. There was a dramatic decrease in total copper concentration in the first spring after the full fire effects were apparent (i.e. summer 2021) at locations impacted by the fire.

Figure 8. Average total copper values for the months of August through October 2018-2022 and the 2023 average value (red dot) at sites included in the LWP SWMP. Light blue bars indicate tributary sites and blue bars indicate mainstem sites.

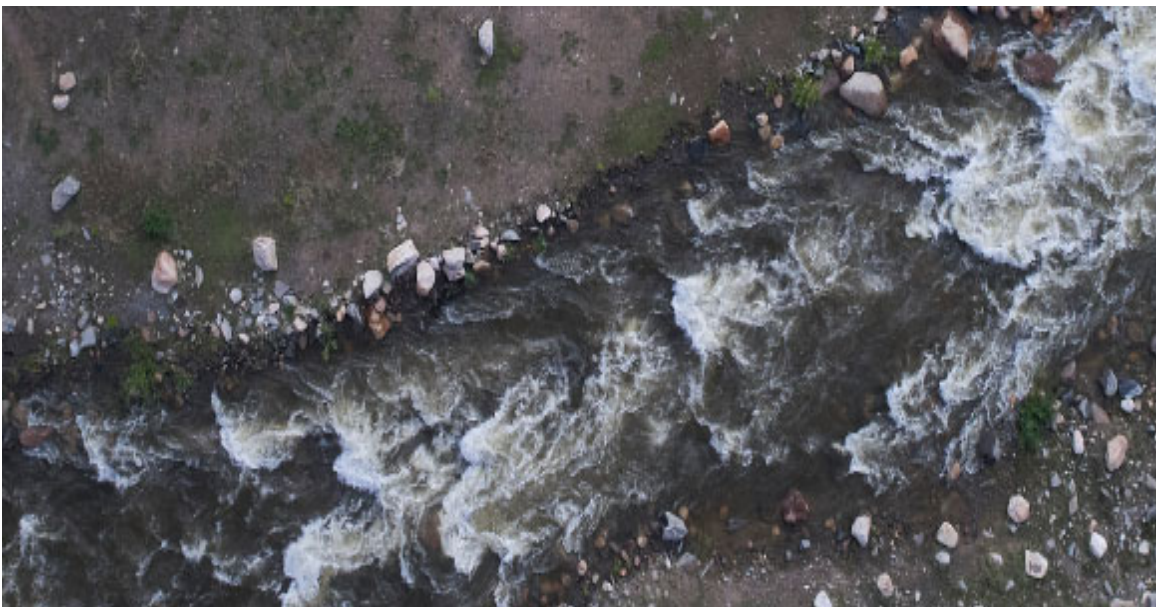
Average total iron concentrations in fall 2023 continued to be somewhat elevated at the S-BTT-20 (North Fork) site compared to the five-year historic average (Figure 9). The area in the North Fork watershed above the sampling site was included in the area that was most severely burned during the CPF in fall of 2020. Increased iron concentrations resulting from the aftereffects of wildfire have persisted for several years and will presumably begin to decline in coming years as the watershed continues to recover from the wildfire.

Figure 9. Average total iron values for the months of August through October 2018-2022 and the 2023 average value (red dot) at sites included in the LWP SWMP. Light blue bars indicate tributary sites and blue bars indicate mainstem sites.

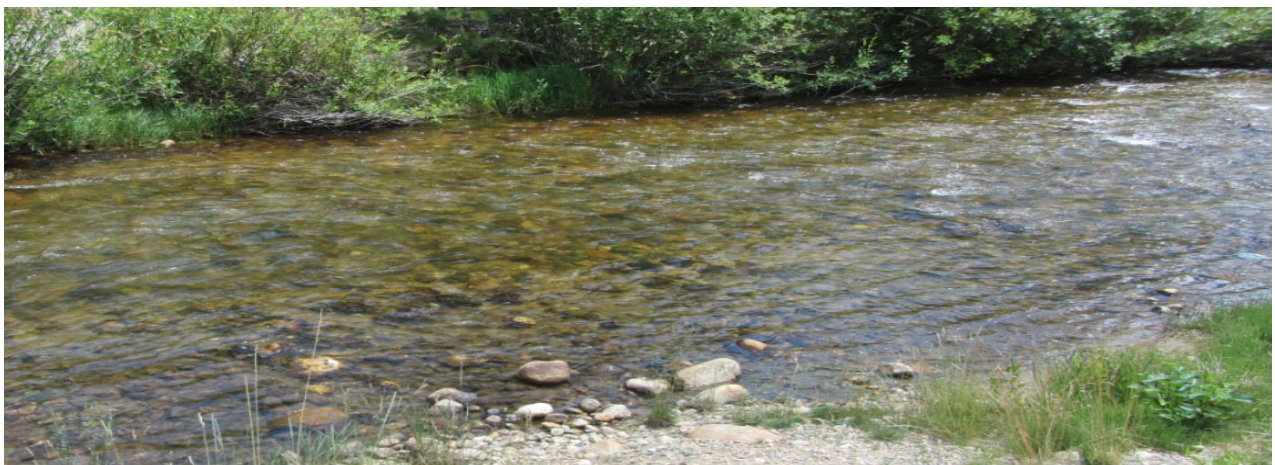
Nitrate concentrations in fall 2023 were generally near five-year average values. Although fall 2023 values appeared near average, concentrations at sites affected by the CPF were substantially lower when compared to average values last year (e.g. S-BTT-20 fall 2022 nitrate concentration = 0.48 mg/L) and last season (e.g. S-BTT-20 summer 2023 nitrate concentration = 1.06 mg/L). Given that elevated nitrate can and has been an aftereffect of the CPF (Rust et al. 2018), near average values are another positive indication that the Big Thompson watershed is recovering from the CPF.

Figure 10. Average nitrate values for the months of August through October 2018-2022 and the 2023 average value (red dot) at sites included in the LWP SWMP. Blue bars indicate mainstem sites, light blue bars indicate tributary sites, and aqua blue bars represent Colorado-Big Thompson sites.

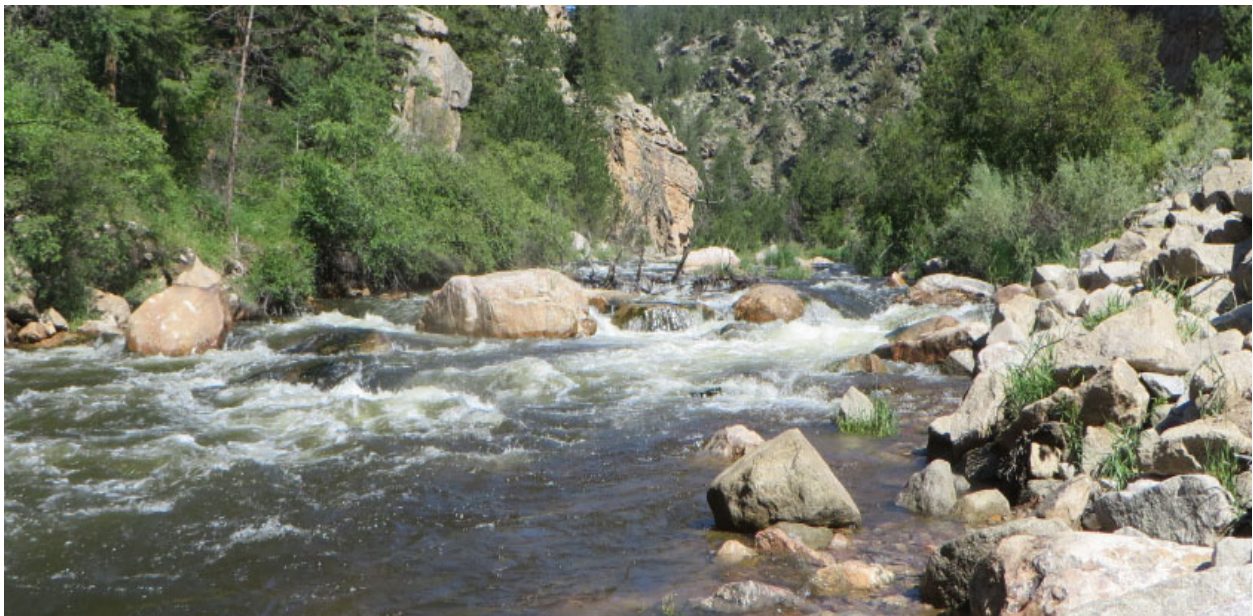
Fall 2023 orthophosphate concentrations were generally low compared to the five-year average values for most sites (Figure 11). This result is a positive one from a water quality perspective and is consistent with wildfire recovery. Hopefully, these low and declining concentrations of orthophosphate will continue in coming years.

Figure 11. Average orthophosphate values for the months of August through October 2018-2022 and the 2023 average value (red dot) at sites included in the LWP SWMP. Blue bars indicate mainstem sites, light blue bars indicate tributary sites, and aqua blue bars represent Colorado-Big Thompson sites.

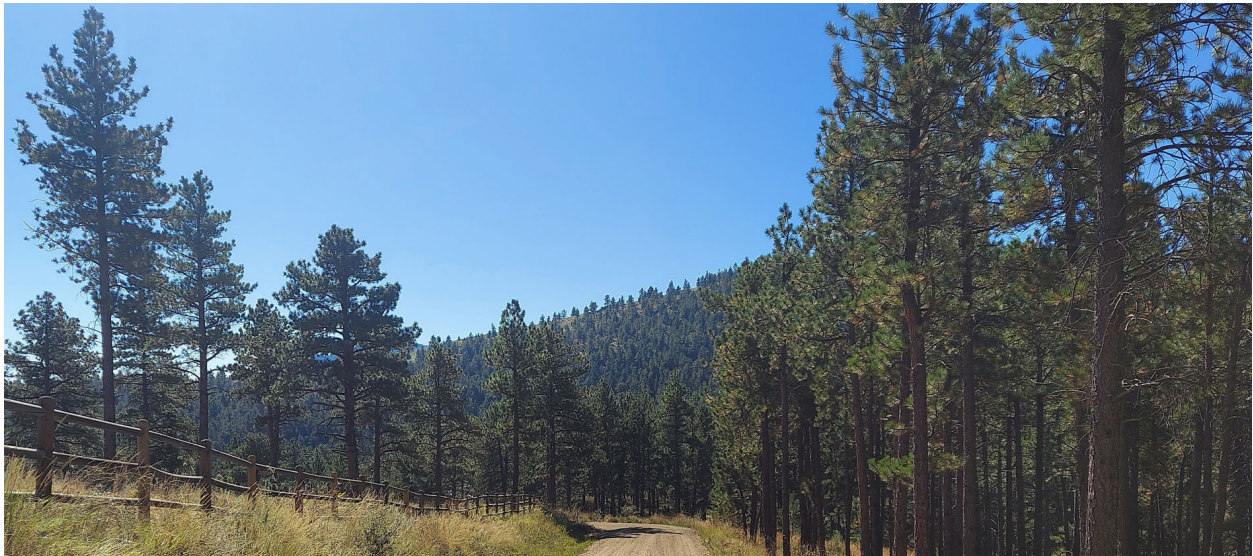
Figure 14. An example of forest management in the Big Thompson River watershed. The forest on the left side of the road has been thinned to historic tree density. The forest on the right side of the road has not been treated.
