# Loveland Water and Power

Big Thompson River Watershed Source Water Quality Conditions Summer 2023

September 11, 2023

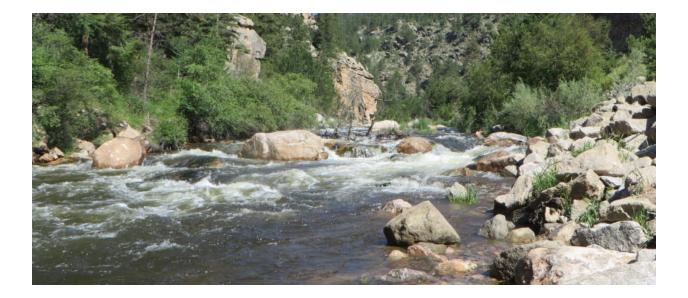
Summer 2023 temperatures were cooler than average values in the past five years (Figure 3). This circumstance is a continuation of cooler temperatures seen in spring and is welcome and somewhat unexpected given the generally increasing temperatures in Colorado.

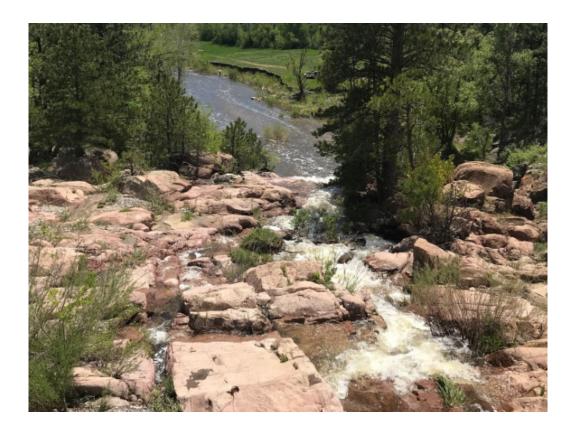
Mean pH values were somewhat elevated at a number of sites in summer 2023 (Figure 5). These elevated values were particularly notable at the sites associated with the CB-T. Higher pH values mean that the water was more basic in 2023 than in previous years. While these increases seem to be modest, pH is measured on a log scale so that a pH increase of one is equivalent to the water being 10 times more basic. White ash from wildfires is generally basic (Rodela et al. 2022). Since all the sites continue to receive some amount of ash from either the CPF or the East Troublesome Fire, it is reasonable to expect pH levels to be somewhat higher than historic values for several years. Although the pH values were somewhat elevated in 2023, none of the values exceeded standards set to protect aquatic life and drinking water sources.

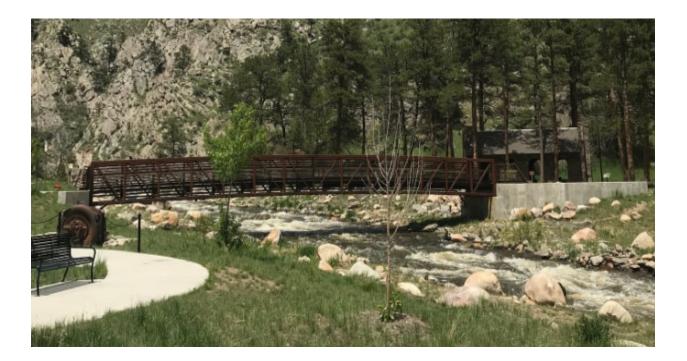
Differences between average values in summer 2023 and average summer values over the previous five years were small.

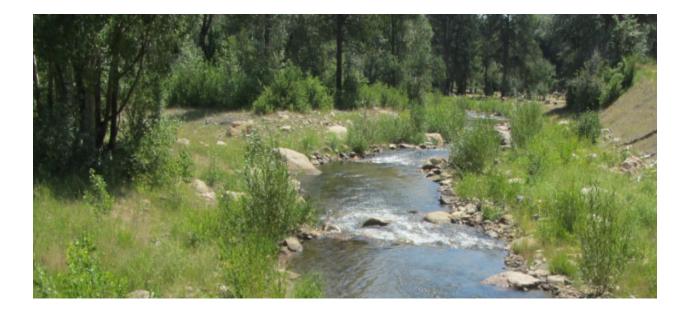
Concentrations of total manganese measured in the sites near the canyon mouth (Figure 7) were generally higher than average, likely due to high turbidities at the same sites. High levels of turbidity are often associated with high concentrations of metals. In addition, increased manganese levels have been associated with the aftereffects of wildfire. As such, elevated levels in the North Fork are likely due to continued effects of the CPF.

The EPA has a "secondary" standard of 0.05 mg/L (ppm) for dissolved manganese. This level does not make water unsafe to drink, but the water may be aesthetically unpleasing due to a reddish/black/brown color which can stain laundry, plumbing, sinks, and showers. Dissolved manganese is a sub-component of total manganese concentrations and as such is always the lower of the two measurements. Although total manganese concentrations were somewhat elevated at some sites, none were above the secondary standard and dissolved manganese levels were certainly lower than the total manganese concentrations displayed in Figure 7.

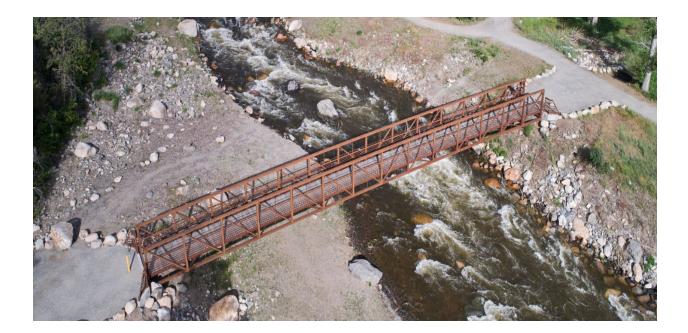
# Figure 8. Average total copper values for the months of May through July 2018-2022 (blue bar) and the 2023 average value (red dot) at sites included in the LWP SWMP.

Total copper levels were near or somewhat below five-year average values in summer 2023 (Figure 8). However, the mean total copper concentration in summer 2023 at site S-BTT-20 (North Fork) is slightly higher than the five-year average value and substantially higher than the same period last year. This circumstance is an indication that the North Fork watershed Is recovering from fire effects. There was a dramatic decrease in total copper concentration in the first spring after the full fire effects were apparent (i.e. summer 2021) at this location. The average total copper concentration was 3.2 mg/L in summer 2020 and 2.2 mg/L in summer 2021. Increases in copper levels towards historic levels may be indicative of watershed recovery in this case. Unfortunately, there is the possibility that the trees killed by the fire may continue to release the copper that they have taken up over the years and release it into the watershed thereby increasing total copper levels even above historical averages.

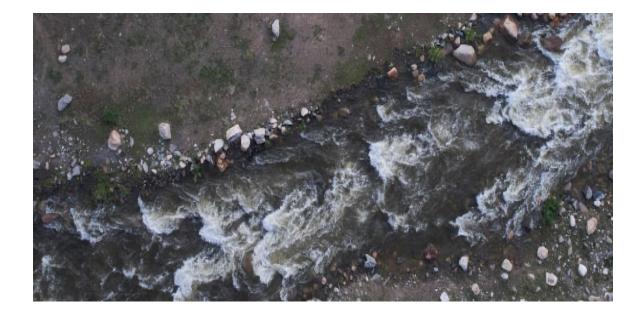
Figure 9. Average total iron values for the months of May through July 2018-2022 (blue bar) and the 2023 average value (red dot) at sites included in the LWP SWMP.

Average total iron concentrations in summer 2023 were somewhat elevated in the S-BTT-20 (North Fork) and downstream to site S-BTR-50 (Narrows Park) compared to the five-year historic average (Figure 9). The area in the North Fork watershed above the sampling site was included in the area that was most severely burned during the CPF in fall of 2020. Increased iron concentrations resulting from the aftereffects of wildfire can persist for a number of years and the elevated total iron level in the North Fork is likely due to the continued effects of the wildfire, including increased turbidity.

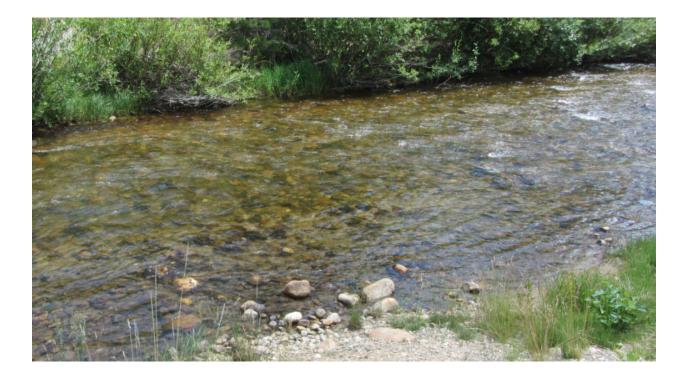
Summer 2023 nitrate concentrations were generally elevated at most sites compared to the fiveyear spring average values (Figure 10). The elevated values seen in the mainstem and tributaries may be the continuing effects of the CPF and the East Troublesome fire (increased nitrate can be an after effect of wildfire) (Rust et al. 2018).

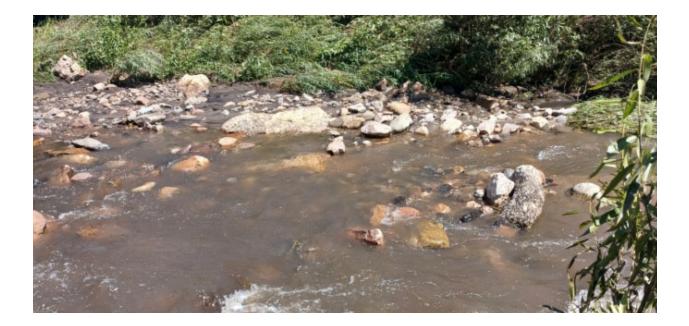
Although only one season of data is currently available, some marked contributions of the Miller Fork are apparent. The most notable results from summer 2023 included nutrients (nitrate and orthophosphate), turbidity, and total manganese (Figure 13). The concentrations of total manganese, orthophosphate, and nitrate from Miller Fork were much higher than concentrations in the North Fork above the confluence of the two streams. The contribution of these water quality constituents from the Miller Fork can be seen in the downstream location on the North Fork (Figure 13) as well as in the mainstem Big Thompson River. Water from the Miller Fork also contributed somewhat to turbidity levels but at a much lower intensity. Even three years after the CPF, water quality parameters continue to be substantially impacted. As mentioned previously, these and other effects of the fire have negative effects on source water quality.
