**Big Thompson River Watershed
Source Water Quality Conditions**

Spring 2023

July 17, 2023

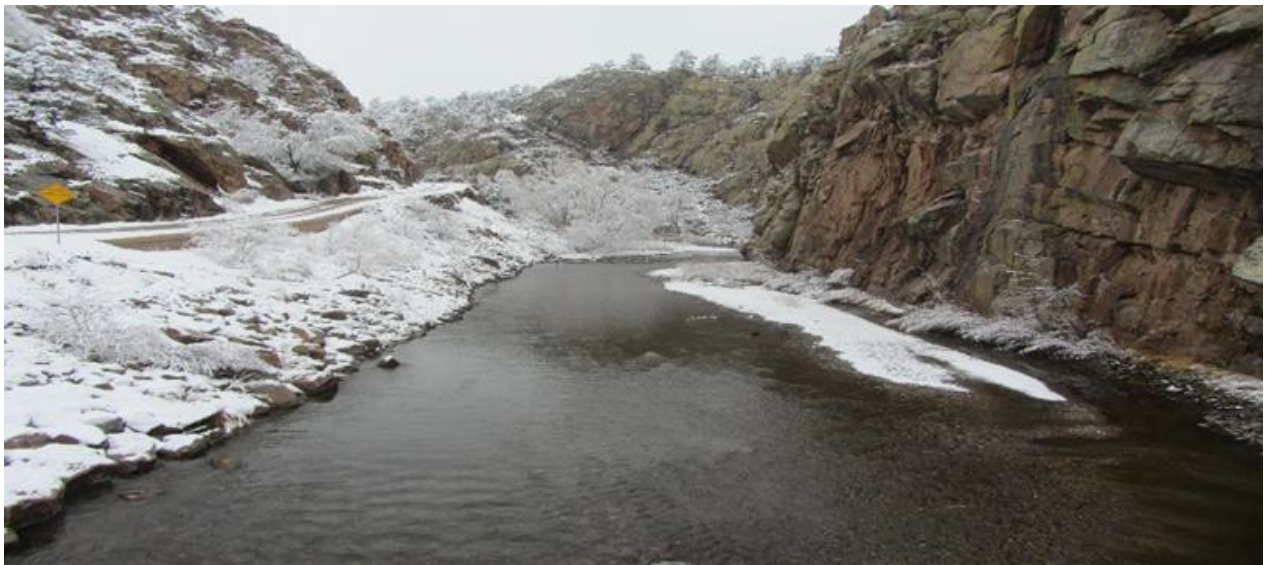
Figure 3. Average water temperature values for the months of February through April 2018-2022 (blue bar) and the 2023 average value (red dot) at sites included in the LWP SWMP.

Spring 2023 temperatures were somewhat lower than average values in the past five years (Figure 3). Given the generally increasing temperatures in Colorado and the region, somewhat cooler temperatures in spring 2023 are closer to average historic values.

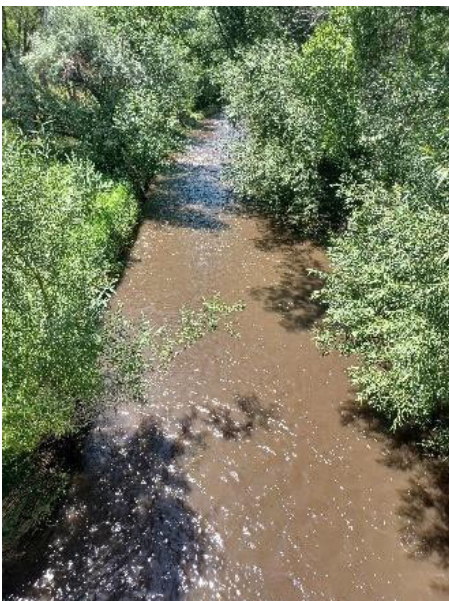
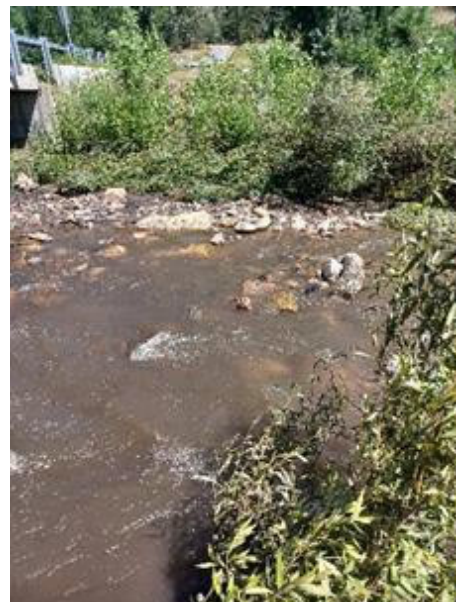
Figure 4. Average turbidity values for the months of February through April 2018-2022 (blue bar) and the 2023 average value (red dot) at sites included in the LWP SWMP.

Turbidity levels in spring of 2023 were near average values for most locations although levels were considerably higher in the North Fork (Figure 4). The area in the North Fork watershed above the sampling site was included in the area that was most severely burned during the CPF in fall of 2020. Increased turbidity resulting from the aftereffects of wildfire can persist for a number of years (Rhoades et al. 2011) and the elevated turbidity level in the North Fork is likely due to these continued effects. Although the average turbidities at the sites near the canyon mouth actually remained somewhat elevated, they appear relatively low compared to the five-year average values due to very high turbidities that occurred during highway 34 construction activities near Drake, CO in March of 2018, which increased overall average values.

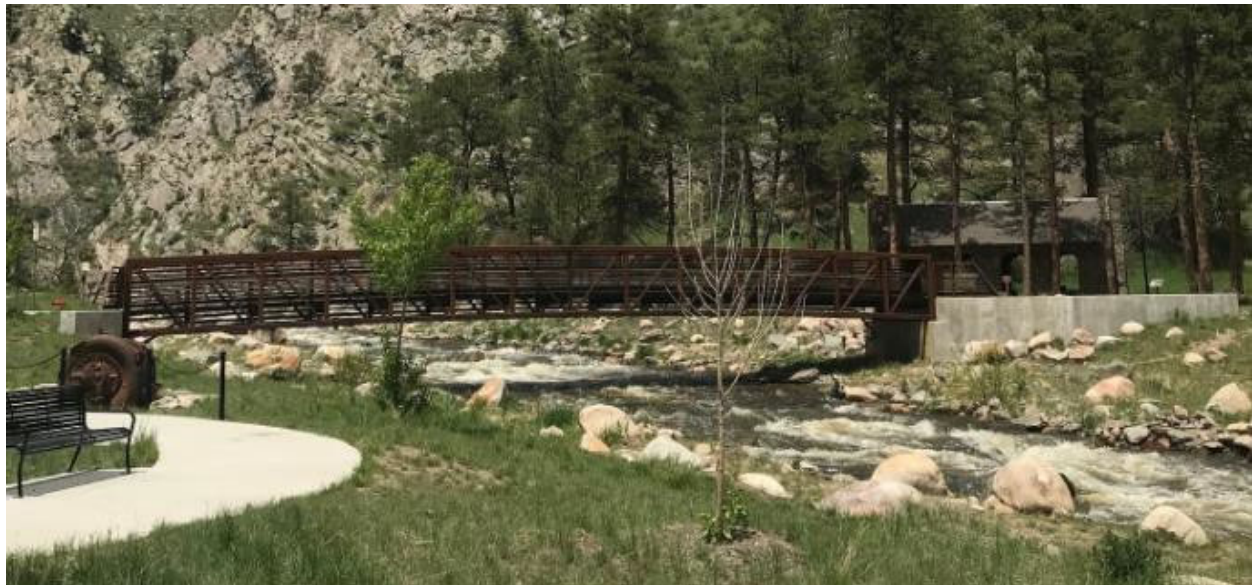
Figure 7. Average alkalinity values for the months of February through April 2018-2022 (blue bar) and the 2023 average value (red dot) at sites included in the LWP SWMP.

Differences between average values in spring 2023 and average spring values over the previous five years were relatively small. However, spring 2023 alkalinity levels in both S-BTR-10 (Mary's Lake Bridge) and S-BTT-20 (North Fork) appear to be somewhat lower than the five-year average value. The only spring sample for these two locations occurred in April. Samples in February and March were not taken due to ice conditions. Higher temperatures can cause decreased alkalinity due to increased influence of snowmelt (Hill and Neal 1997). The fact that the only alkalinity values available for these two sites was from the warmest of the three months included in the mean value may be the cause of these apparently lower values.

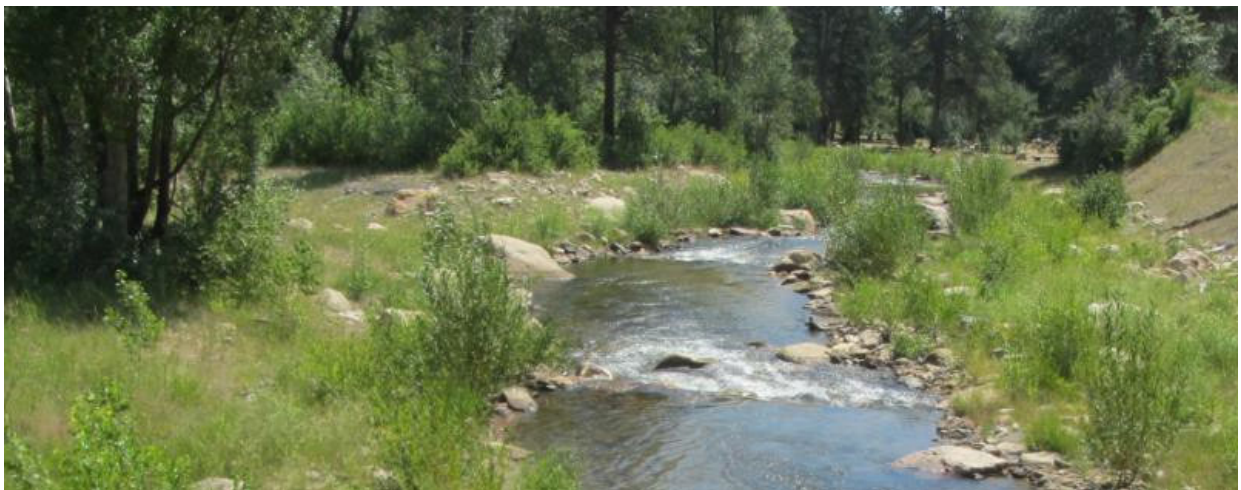
Figure 7. Average total manganese values for the months of February through April 2018-2022 (blue bar) and the 2023 average value (red dot) at sites included in the LWP SWMP.

As with the average turbidity levels measured in spring of 2023, the values for dissolved manganese measured in spring 2023 in the sites near the canyon mouth (Figure 7) are lower than average, likely due to very high turbidities in March of 2018 as a result of highway 34 construction activities near Drake, CO. High levels of turbidity are often associated with high concentrations of dissolved metals. In addition, increased dissolved manganese levels have been associated with the aftereffects of wildfire. As such, elevated levels in the North Fork are likely due to continued effects of the CPF.

The EPA has a “secondary” standard of 0.05 mg/L (ppm) for dissolved manganese. This level does not make water unsafe to drink, but the water may be aesthetically unpleasing due to a reddish/black/brown color which can stain laundry, plumbing, sinks, and showers. Although the mean total manganese value at site S-BTT-20 (North Fork) was above this secondary standard, dissolved manganese values were substantially lower and dilution in the main stem Big Thompson reduced this concentration prior to reaching the LWP drinking water intake.

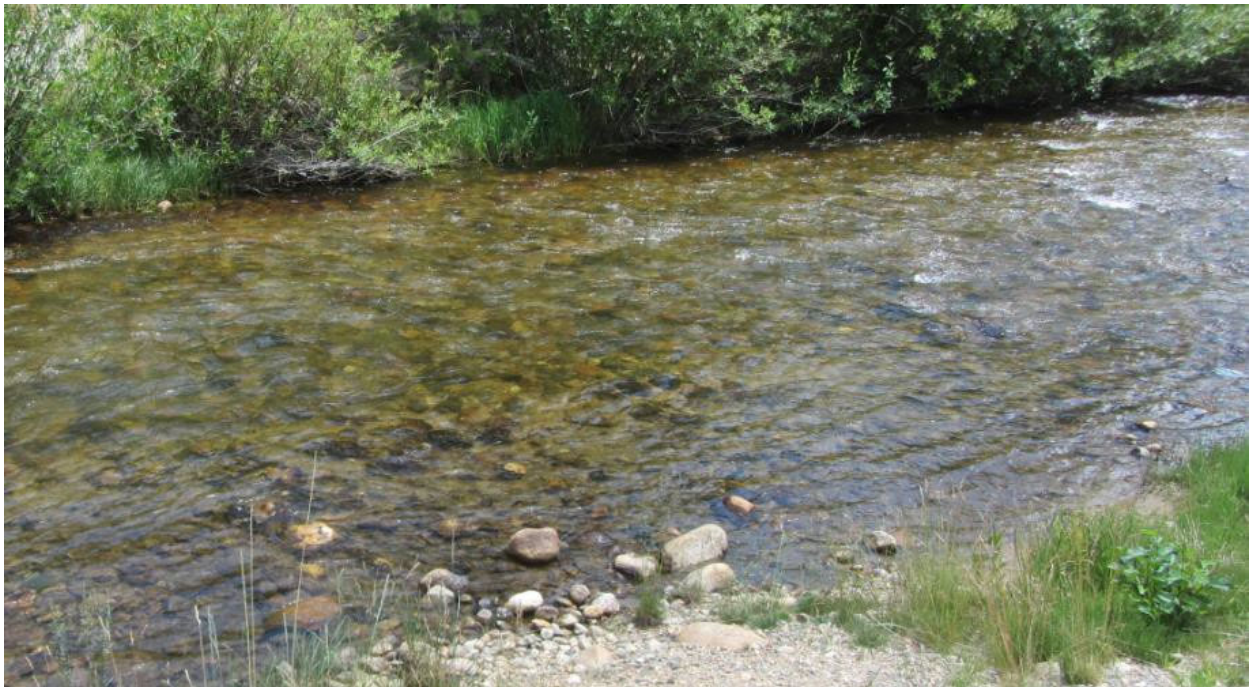
Figure 10. Average nitrate values for the months of February through April 2018-2022 (blue bar) and the 2023 average value (red dot) at sites included in the LWP SWMP.

Spring 2023 nitrate concentrations were generally elevated at most sites compared to the five-year spring average values (Figure 10). The elevated values seen in the mainstem and tributaries may be the continuing effects of the CPF and the East Troublesome fire (increased nitrate can be an after effect of wildfire) (Rust et al. 2018).
